E-470 Public Highway Authority

# 2020 Annual Certification

# 2020 E-470 Annual Certification Report

Prepared for E-470 by Short Elliott Hendrickson Inc. (SEH)

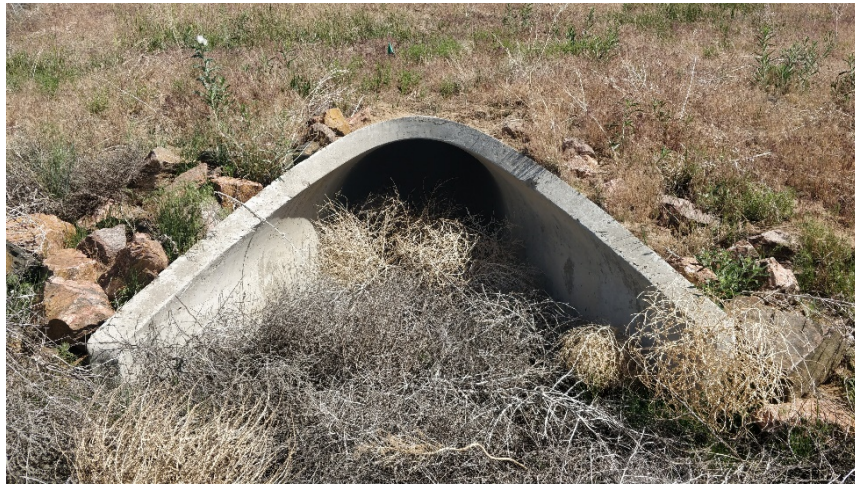
The Authority maintains 59 box culverts, which are inspected every two to four years for structural concerns. The frequency is determined by the culvert's clear opening as described in Section 2.2.2. The Authority also maintains 160 reinforced concrete pipe culverts. For the Annual Certification, a random sample of 10 concrete box culverts and 15 reinforced concrete pipe culverts are inspected for sediment, trash, tumbleweeds, and capacity. Seven culverts were found to have sediment greater than 4" and three were found to have tumbleweeds impacting the water flow. Trash was only found in three of the culverts. See Figure 2-1 below for an example view of moderate tumbleweed blockage at the end of a reinforced concrete pipe (south of Toll Plaza C). **The culverts are in excellent condition with an overall score of 98.1.**

Figure 2-1 – Reinforced Concrete Pipe Flared End with Tumbleweed Build-Up

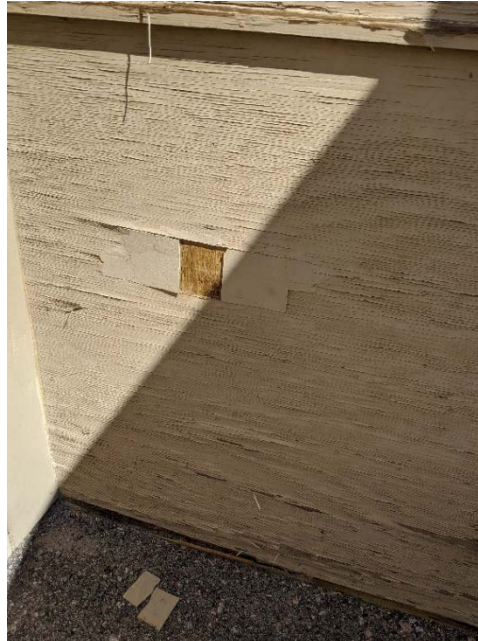
- Central Maintenance Facility: The building was in excellent condition with a rating of 97.00. The only Level Two item was damages and discoloration to plywood paneling/sheeting. The exterior wood was described as being in bad shape at the time of inspection (Figure 2-2). There were two Level Three findings found in the buildings. These findings include voids larger than ½ inch in the brick mortar and water damages or discoloration to ceiling, floors, or walls.

Figure 2-2 – Damages to Exterior Wood

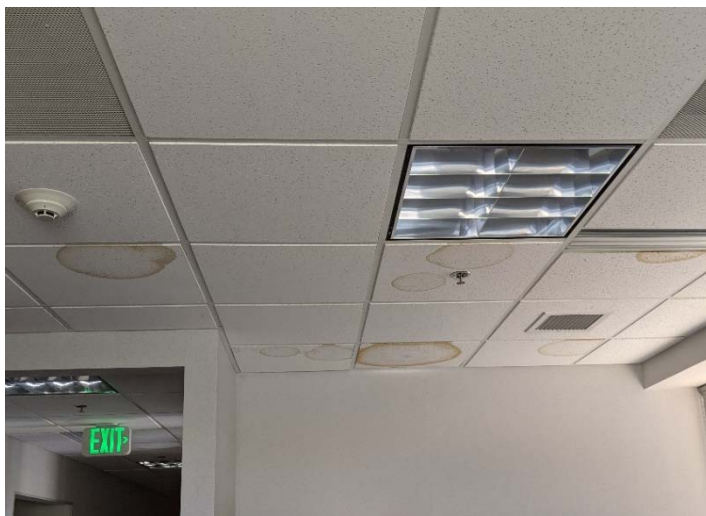
- Toll Plaza E: The building is in excellent condition with an overall rating of 96.75. There was only one Level Two finding. It was noted that there was water damage and discoloration to ceiling tiles throughout the interior of the building (Figure 2-3).

Figure 2-3 - Water Damages and Discoloration to Ceiling

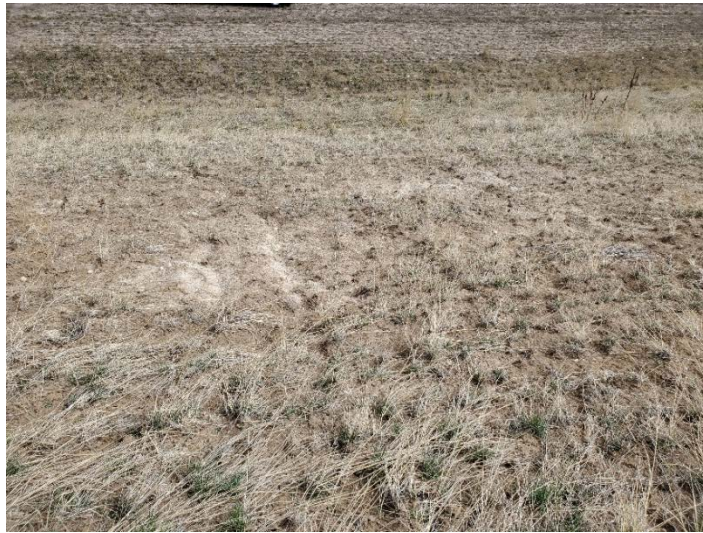
One portion between Quincy Ave. and Smoky Hill Road, at Milepoint 12.0 traveling south, had four bare spots, three areas with erosion greater than 10 feet in length, along with two other areas of erosion less than 10 feet in length, see Figure 2-4.

Figure 2-4 – Erosion and Bare Spots at Milepoint 12.0 (Southbound)

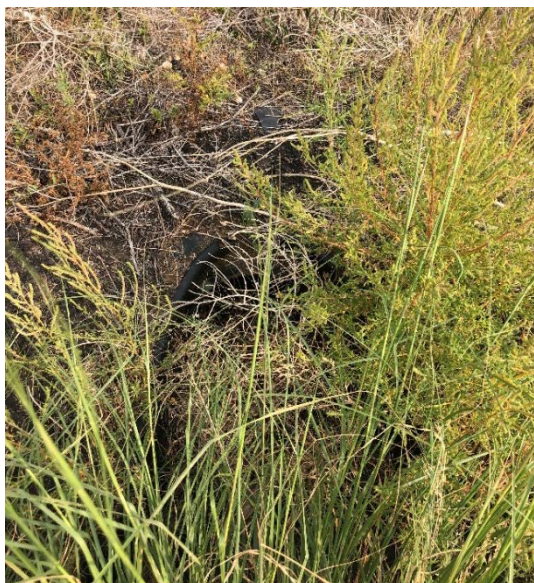
The top opening of the embankment protector northwest of 88<sup>th</sup> Ave. has significant plant overgrowth (see Figure 2-5). The bottom opening is also overgrown with plants and blocked approximately 15% with tumbleweeds and sediment.

Figure 2-5 – Top of Embankment Protector near 88<sup>th</sup> Ave.
