E-470 Public Highway Authority
2021 Annual Certification

2021 E-470 Annual Certification Report

Prepared for E-470 by Short Elliott Hendrickson Inc. (SEH)

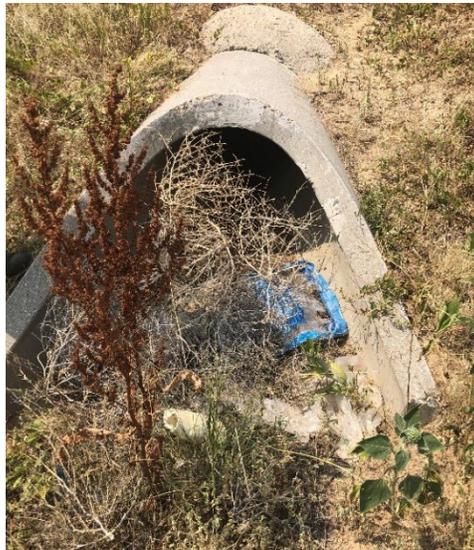
Figure 2-1 – Reinforced Concrete Pipe Flared End with Tumbleweed and Trash Build-Up

Level	Location	Description of Finding
One	Embankment Protector at 104th Ave. (northwest)	Bottom opening significantly restricted (~45%), severely cracked asphalt pavement at top opening
Two	Exit Ramp Sign at NB 64th Ave. Off-Ramp	Low retro-reflectivity reading of Yellow background, retro-reflective sheeting "chipping" off
Two	Native Seeding Area near NB Jordan Rd Off-Ramp	Large bare spot and erosion greater than 12" in depth
Two	Snow Fence along NB Colorado Blvd. On-Ramp	Fabric deficiencies throughout stretch, evidence of vehicle driving through fence
Two	Toll Plaza B	Water damages and discoloration to ceiling tiles and floor (extensive throughout interior)
Two	Toll Plaza E	Water damages and discoloration to ceiling tiles and floor (extensive throughout interior)
Two	Toll Plaza E	Standing water at end of tunnel (¼" in depth)
Three	RCP south of Colorado Blvd. bridge	Opening blocked 25% by trash, and 36" of tumbleweeds for length of 10'

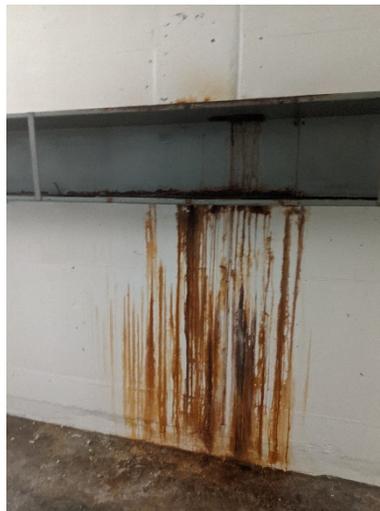
- Toll Plaza A: The building is in excellent condition with an overall rating of 91.00. There were no Level One or Two findings. The following items noted are Level Three findings: 1) voids larger than ½ inch in brick mortar on the building exterior, 2) chipping of bricks on exterior of structure, 3) chip at corner of structural foundation on exterior of building, 4) soffit peeling on exterior of building, 5) water damages and discoloration to ceiling tiles throughout building interior, 6) crack in drywall and evidence of slab settlement, 7) unrepaired cracks in concrete wider than ¼ inch in tunnel, and 8) visible water damage on wall of tunnel (at least 12 inches in height). Evidence of water in the tunnel is shown in Figure 2-2.

Figure 2-2 – Evidence of Water on Tunnel Wall in Toll Plaza A

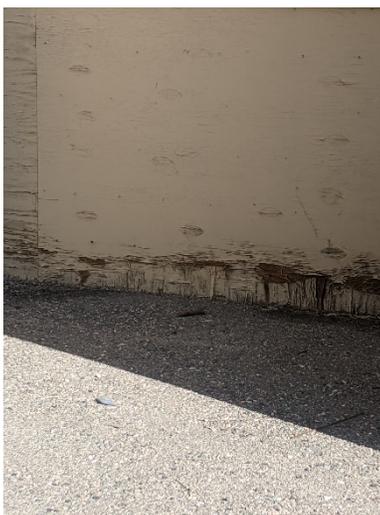
- Toll Plaza D: The building is in excellent condition with an overall rating of 94.50. No Level One or Two findings were noted. The Level Three findings were: 1) soffit peeling on exterior of building, 2) cracks in concrete larger than ¼ inch inside buildings, 3) water damages and discoloration to ceiling tiles, and 4) unrepaired cracks in concrete wider than ¼ inch in tunnel.
- MSS D: The building is in excellent condition with an overall rating of 96.50 with the Level Three findings being damage and discoloration to plywood paneling/sheeting on building exterior and visible structural damage (cracking) of interior building drywall. Figure 2-3 is an area of damaged plywood paneling/sheeting on the building exterior.

Figure 2-3 – Damage to Plywood Paneling/Sheeting on MSS D Exterior

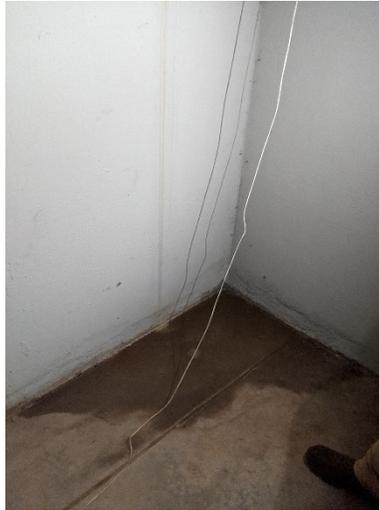
- Toll Plaza E: The building is in good condition with an overall rating of 87.25. There were two Level Two findings. There was water damage and discoloration to ceiling tiles and floor through the interior of the building. A total of 44 ceiling tiles were stained at the time of inspection. Also, there was at least ¼ inch of standing water at the end of the tunnel (Figure 2-4). There were four Level Three findings. These findings include 1) exterior structural damage of bricks, 2) soffit peeling on exterior of building, 3) unrepaired cracks in concrete wider than ¼ inch in tunnel, and 4) visible water damage on the walls of the tunnel.

Figure 2-4 – Standing Water at End of Tunnel in Toll Plaza E

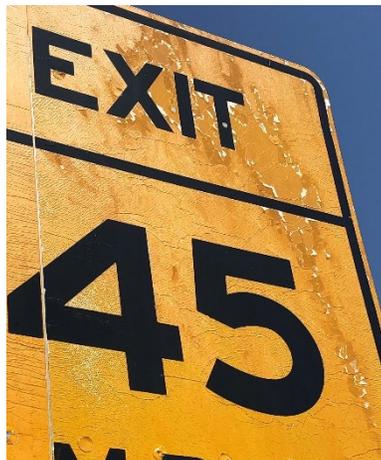
Figure 2-5 – Retro-reflective Sheeting Damage on Exit Ramp Sign

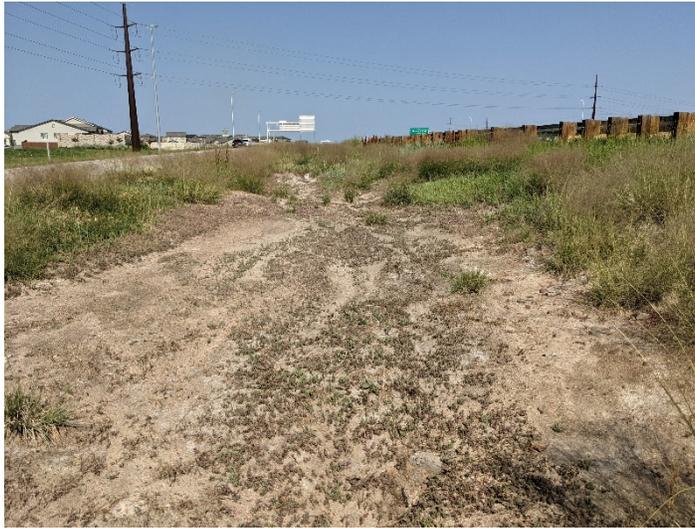
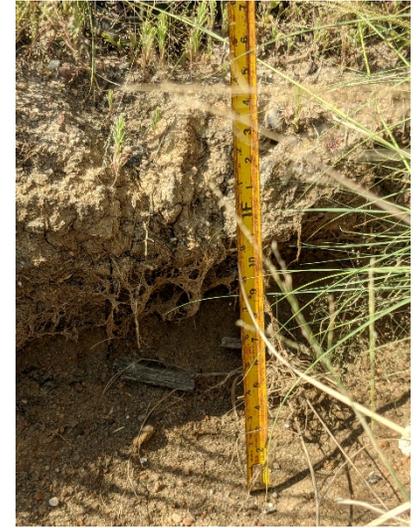
One portion at the NB Jordan Rd Off-Ramp presents a large bare patch and over one foot of erosion, likely caused by stormwater runoff, see Figure 2-6 and 2-7.

Figure 2-6 & 2-7 – Bare Spot and Erosion at Jordan Road Off-Ramp (Northbound)

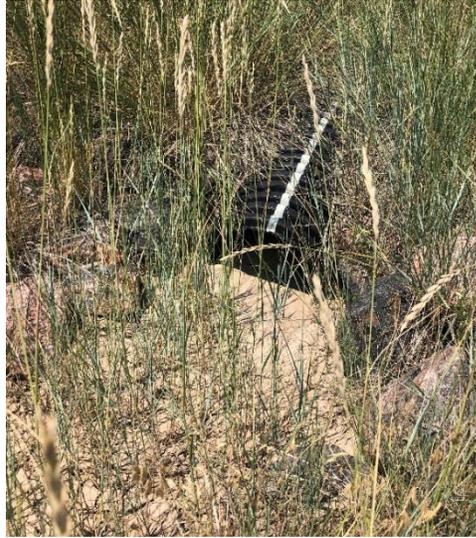
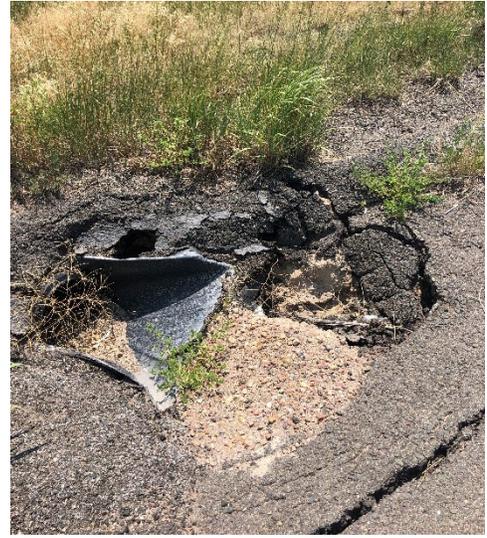
The bottom opening of the embankment protector on the northeast corner of the 104th Ave bridge has significant blockage (about 45%) due to sediment. The top opening has moderate blockage due to sediment but the asphalt pavement surrounding the top opening is severely damaged. The blockage and damages of the bottom and top openings are shown below in Figures 2-8 and 2-9.

Figure 2-8 & 2-9 – Bottom and Top of Embankment Protector near 104th Avenue
