E-470 Public Highway Authority

2022 Annual Certification

2022 E-470 Annual Certification Report

Prepared for the E-470 Public Highway Authority by Short Elliott Hendrickson Inc. (SEH)

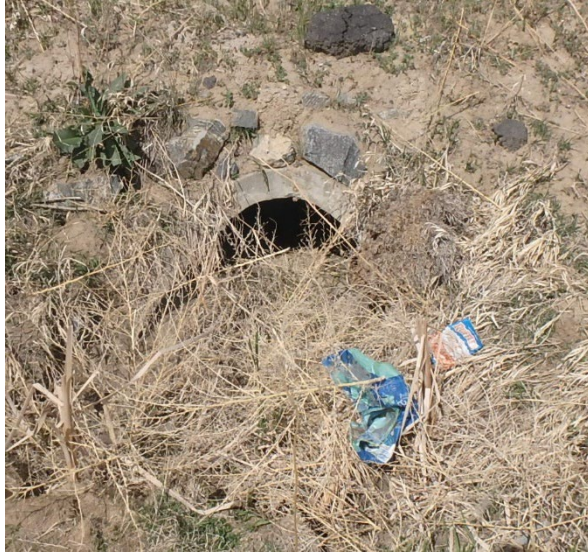
Figure 2-1 – Reinforced Concrete Pipe Flared End with Tumbleweed and Trash Build-Up

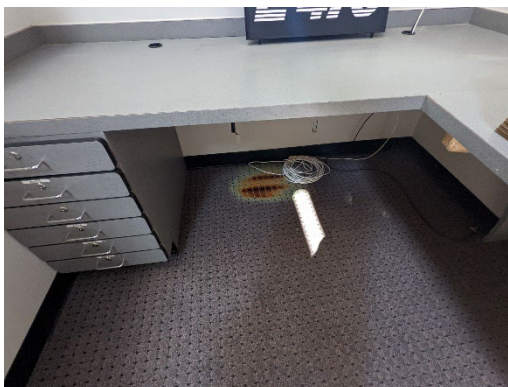
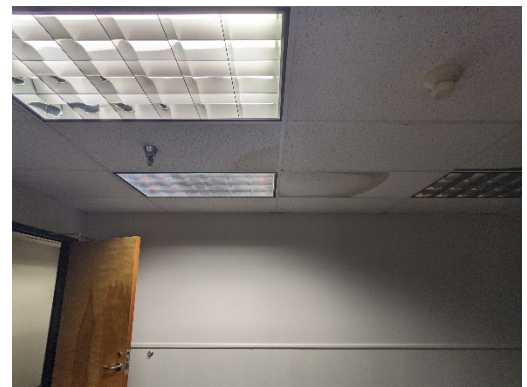
- Toll Plaza A: The building is in excellent condition with an overall rating of 94.50. The only Level Two finding was significant water damages and discoloration to ceiling tiles and floor throughout the building interior. The following items noted are Level Three findings: 1) voids larger than ½ inch in brick mortar on the building exterior near the entryway, 2) broken bricks on exterior of structure at garage, 3) chip in structural foundation stem wall on exterior of building, and 4) soffit peeling on exterior of building. Evidence of floor and ceiling stains shown in Figure 2-2.

Figure 2-2 – Water Stain on Floor and Ceiling in Toll Plaza A

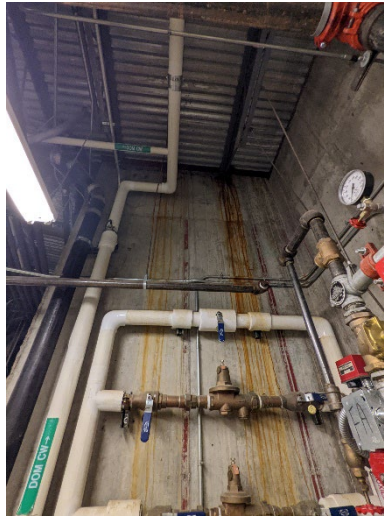
- Toll Plaza D: The building is in excellent condition with an overall rating of 95.50. No Level One findings were noted and the only Level Two finding was water damages and discoloration to ceiling tiles and wall. Only two Level Three findings were discovered. These items were soffit peeling on the exterior of the building and visible leaks in the ceiling contributing to the damage and discoloration of some ceiling tiles. Figure 2-4 shows significant staining on the basement wall.

Figure 2-3 – Stain on Basement Wall in Toll Plaza D

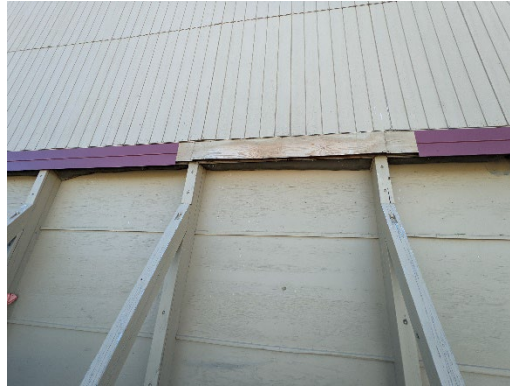
- MSS D: The building is in excellent condition with an overall rating of 95.75 with the following Level Three findings: base connections at the timber columns beginning to rust and damaged plywood paneling on the building exterior. Figure 2-3 is an area of damaged plywood paneling/sheeting on the building exterior with cladding missing in one location.

Figure 2-4 – Damage to Plywood Paneling/Sheeting and Missing Cladding on MSS D Exterior

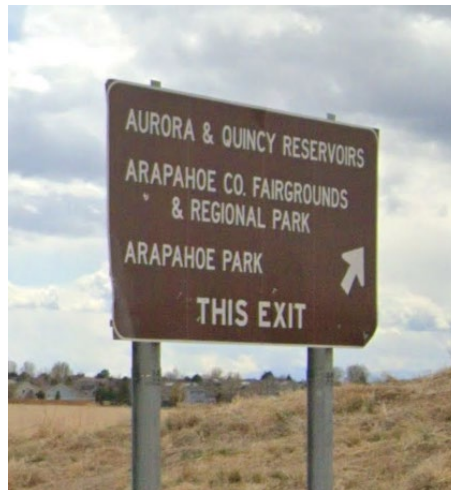
The Authority maintains approximately 4,000 signs and targets for 95% to be in good condition with no damage, and that they are secure, straight, and have good retro-reflectivity during both the day and at night. Forty signs were chosen randomly for inspection. Each sign was assessed for secureness to post, if the sign was bent, cleanliness, if the sign or posts were out-of-plumb by more than 1 inch per 4 feet of height, and whether the sign was unreadable during daytime or nighttime conditions. One sign was visible during the daytime but was not clearly visible at night. The sign is rotated towards mainline traffic and almost completely away from vehicles traveling the On Ramp. Figure 2-5 shows the orientation of the W4-1 “Merge” sign located between northbound E-470 and the northbound On Ramp at Peoria St.

Figure 2-5 – Chipped and Fading Sign SB Before Quincy Ave Off Ramp

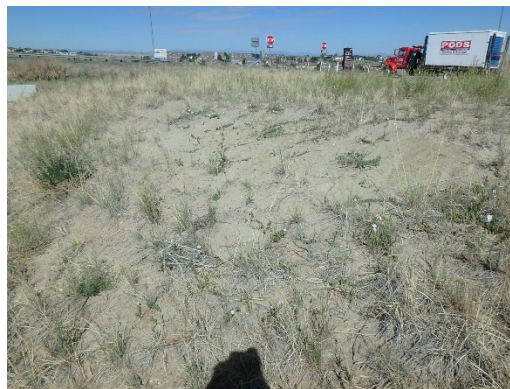
One portion north of Gartrell Road between the Off Ramp and mainline has many large bare patches, see Figure 2-6. This area also showed evidence of erosion between 2 and 12 inches in depth. Another area where large bare stretches were observed was near the Gun Club Road interchange along the right main lane shoulder, shown in Figure 2-7.

Figure 2-6 – Bare Spot Northeast of Gartrell Road between Off-Ramp and Mainline

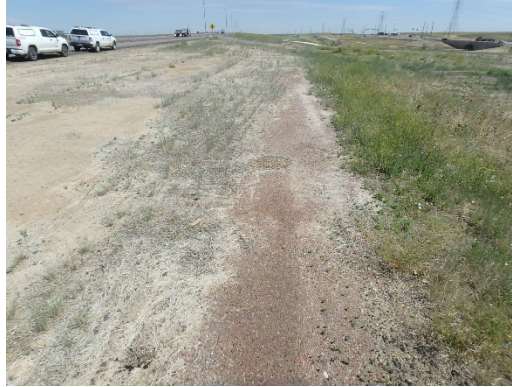
Figure 2-7 – Bare Seeding Area Between Right Shoulder and Gun Club Rd. Near Interchange
