E-470 Public Highway Authority

2023 Annual Certification

2023 E-470 Annual Certification Report

Prepared for the E-470 Public Highway Authority by Short Elliott Hendrickson Inc. (SEH)

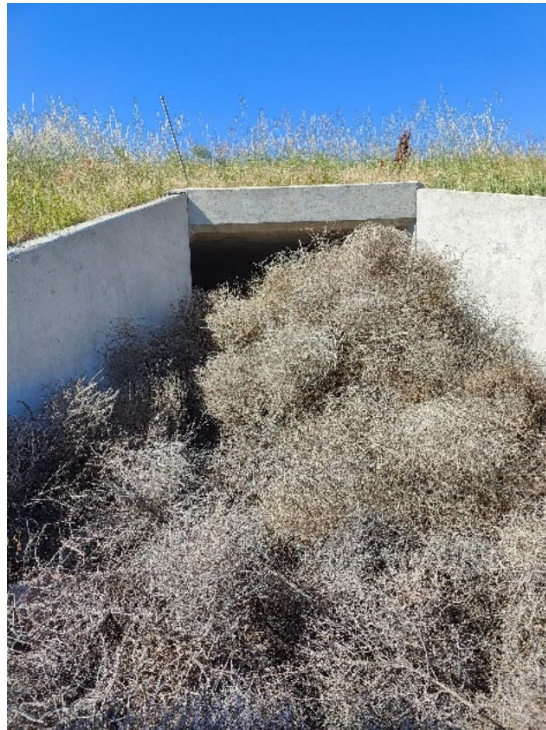
No culverts were found to have sediment greater than 4", and two culverts were found to have tumbleweeds impacting the water flow. Trash was present in only one of the pipes, which seemed significantly blocked with a combination of trash and sediment. See **Figure 2-1** for an example of major tumbleweed blockage, and **Figure 2-2** for a picture of the fully underwater pipe that appeared blocked. **Overall, the box culverts are in excellent condition with an average score of 99.20. The reinforced concrete pipes were also in the excellent condition range at an average of 93.33. Both drainage assets combined averaged a 96.27**

Figure 2-1 – Box Culvert with Significant Tumbleweed and Trash Build-Up at MP 33.55

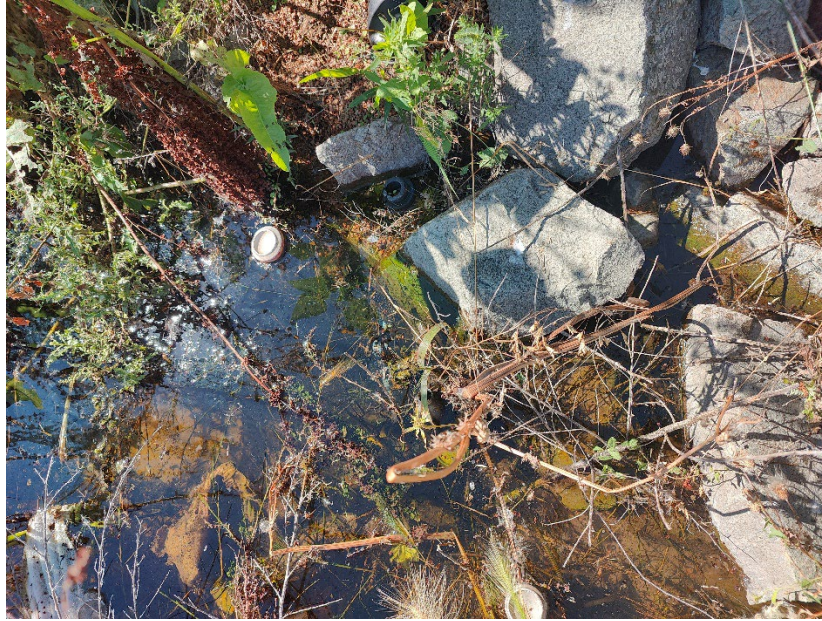
Figure 2-2 – RCP Underwater, Appearing Clogged at Time of Inspection at MP 38.45

Level	Asset Type	Location	Description of Finding
One	Drainage	RCP at MP 38.45 NB side (between bridges)	Pipe is fully submerged and appeared blocked at time of inspection. Further investigation should be performed to determine level of blockage and if area drainage is functioning correctly.
One	EPs	SB SW corner of Tower bridge	Mid-pipe joint is cracked and leaking water, causing hillside erosion. Outlet is approximately 25% blocked with debris.
One	Signing	45MPH Exit Sign at 96 th off ramp traveling NB	Sign is not reflective and not readable at night. 96 th Avenue NB Off-Ramp area signs appear in need of replacement.
Two	Buildings	MSS A	Water damage and discoloration to the ceiling and walls.
Two	Buildings	TP A	Leaks in the doors and window seals. Rust on the HVAC system.
Two	Buildings	TP B	Standing water of greater than ¼ inch in depth in the tunnel facility, along with clogged drains.
Two	Buildings	TP D	Standing water of greater than ¼ inch in depth in the tunnel facility.

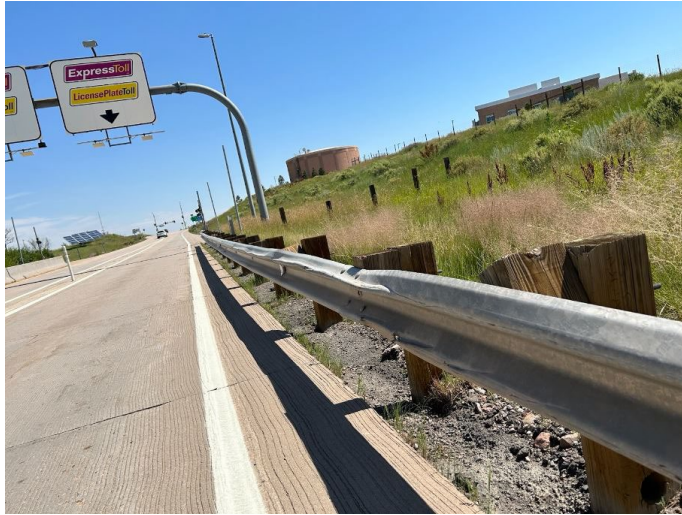
Figure 2-3 – Minor Guardrail Damage Observed

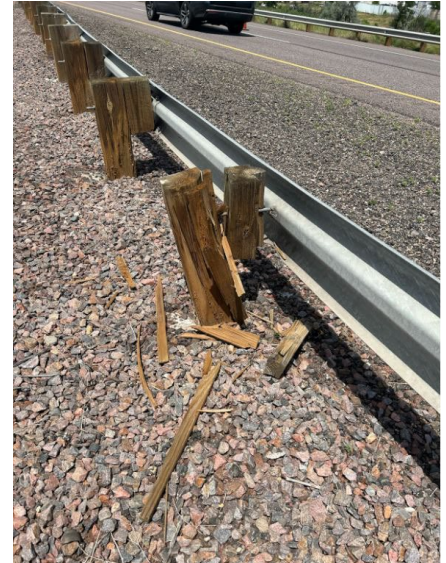
Figure 2-4 – Typical Guardrail Post Damage

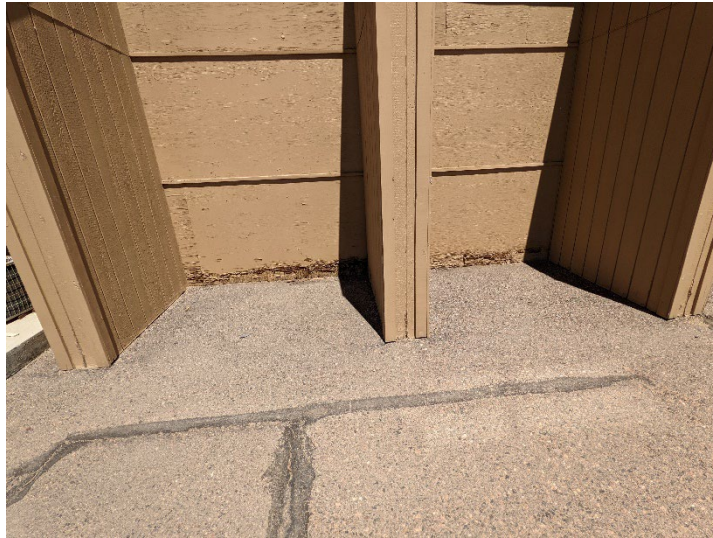
- MSS D: The building is in excellent condition with an **overall rating of 98.25** with the following Level Three findings: spalling on the concrete piers and multiple locations of damage or discoloration to plywood paneling/sheeting on the building exterior. Figure 2-5 below is an example of the plywood damage observed.

Figure 2-5 – MSS D – Observed Plywood Damage

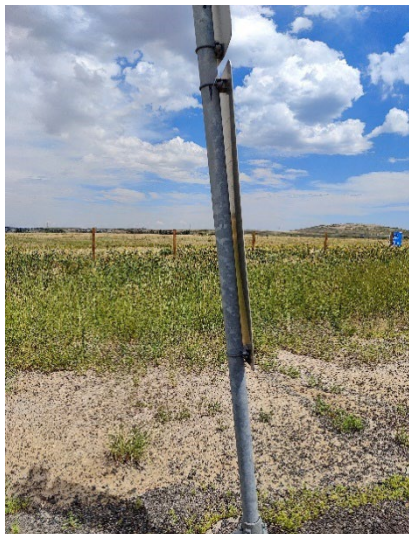
Forty signs were chosen randomly for inspection. Each sign was assessed for secureness to post and base. Points were deducted for signs that were bent, unclean, out-of-plumb by more than 1 inch per 4 feet of height, and/or unreadable during daytime or nighttime conditions. Three signs were found to be loose at the panel attachment or base. Three signs were found to be out of plumb and three signs were found to be partially bent. **Figure 2-6** below displays an out of plumb sign which is a result of a loose connection from sign base to post.

Figure 2-6 – Out of Plumb Sign near NB Jewell Avenue

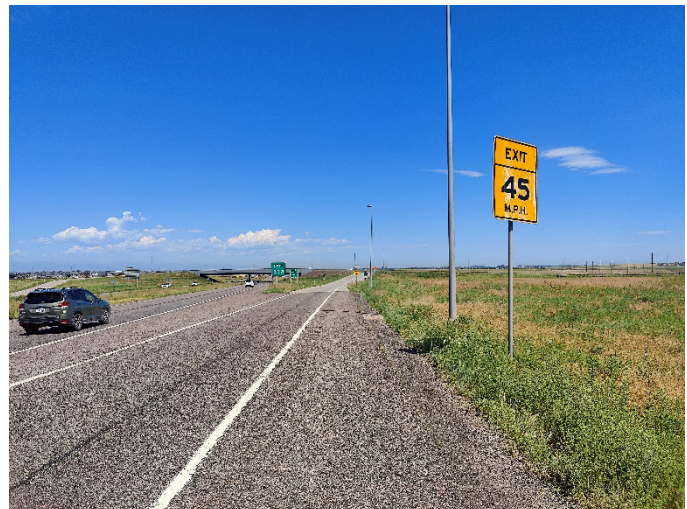
The most significant sign observation was that the 45mph exit warning sign at northbound (NB) 96th Avenue was found unreflective during testing. These equipment readings were confirmed during our nighttime drive, where the sign was unreadable. While no other NB 96th Avenue signs were on the random selection inspection list, the inspection team noted that almost all the signs in the vicinity of this exit ramp had low to no reflectivity and were difficult to read during the night inspection drives. The inspection team strongly recommends that all the signs in this area be replaced. The Authority confirms that these 9th Ave signs will be replaced as part of the ongoing widening project. **Figure 2-7** below displayed the location of this sign relative to the exit ramp.

Figure 2-7 – Nonreflective Exit Sign at NB 96th Avenue

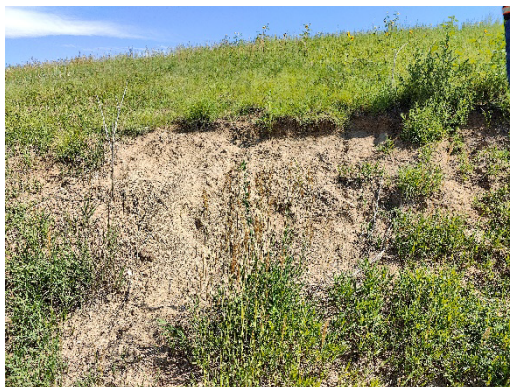
Heavy rain events in recent months have caused many areas along the E-470 corridor to experience higher than normal storm water runoff, which in turn create areas of erosion. Figures 2-8 and 2-9 below display erosion and sediment areas observed.

Figure 2-8 – Erosion Between NB Jamaica On Ramp and Mainline

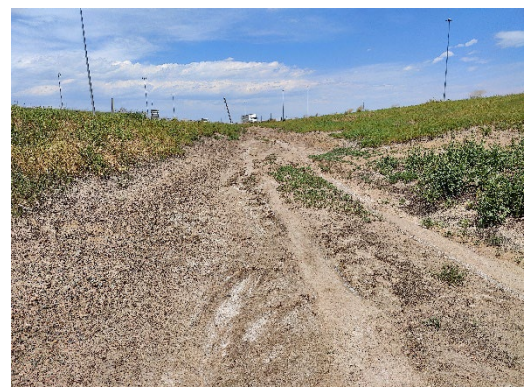
Figure 2-9 – Large Rain Runoff Area at SB Peña Blvd Off Ramp

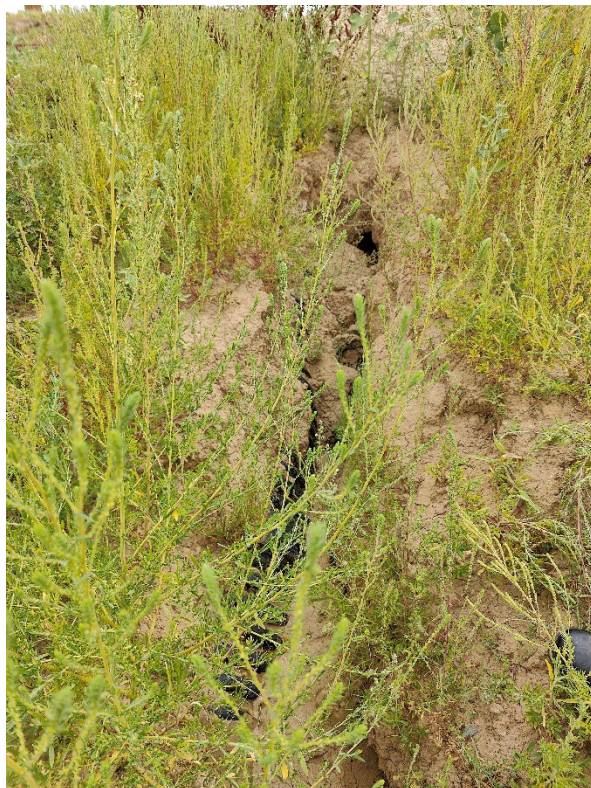
Similar to the previously detailed culvert inspections, embankment protectors (EPs) are inspected for debris and depth of erosion at the discharge location. Fifteen (15) embankment protectors out of the seventy maintained by the Authority were randomly selected for inspection. Three out of the 15 embankment protectors inspected had openings restricted by at least 50%. Two showed signs of erosion at either the inlet or outlet end. One location of note was the EP at the SW corner of the Tower Road bridge; this EP pipe has a crack at the midpoint joint through which water is escaping and causing hillside erosion and exposing the pipe. Figure 2-10 below showcases this exposed pipe. **The overall condition of this asset is good, with an average score of 84.13.**

**Figure 2-10 – Tower Road Bridge SW Corner
Embankment Protector Erosion**
