E-470 Public Highway Authority

# 2024 Annual Certification

# 2024 E-470 Annual Certification Report

Prepared for the E-470 Public Highway Authority by Short Elliott Hendrickson Inc. (SEH)

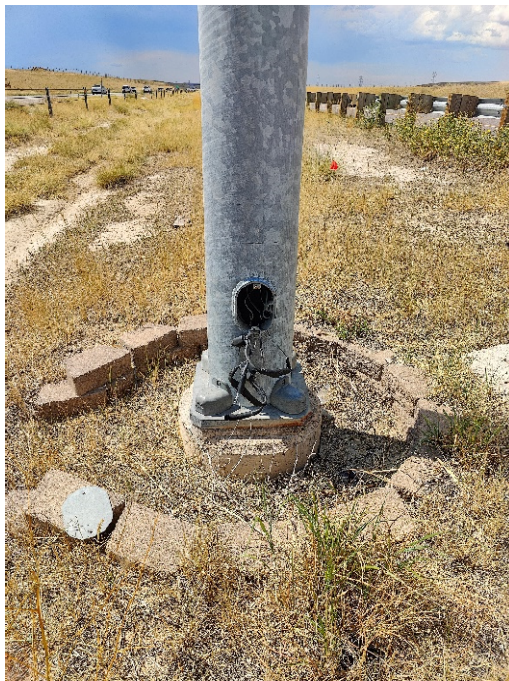
A random selection of 146 lights (10%) were inspected for bolt tightness, weld conditions, rust, cracks, flaking paint, and erosion around the poles. **The detailed light inspection confirmed the lights are in excellent operating condition with the average individual light achieving a score of 99.68.** We found no loose anchor bolts during inspection. Rust, weld, or paint issues were present on 37 light poles at the time of inspection. It was noted for informational purposes that 33 of these faults were electrical access panel doors or plates missing or detached on the ground. Examples of this are depicted in Figures 2-1 and 2-2 below.

**Figure 2-1 – Open access panel with wires exposed, median at Toll Plaza B**

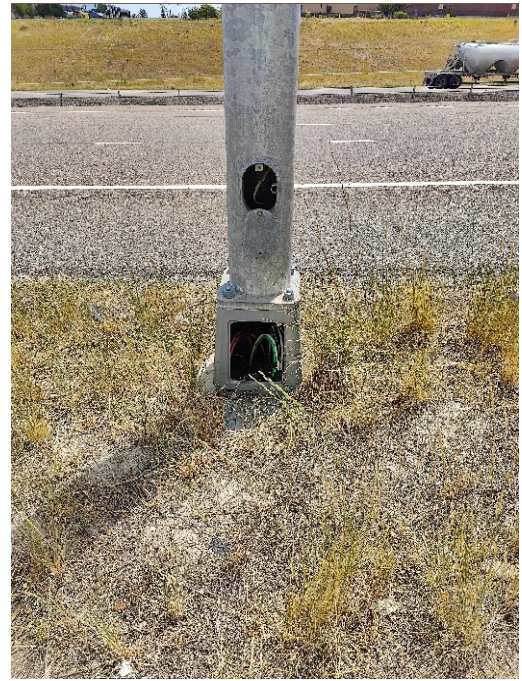
**Figure 2-2 – Multiple open access panels, observed at multiple locations**

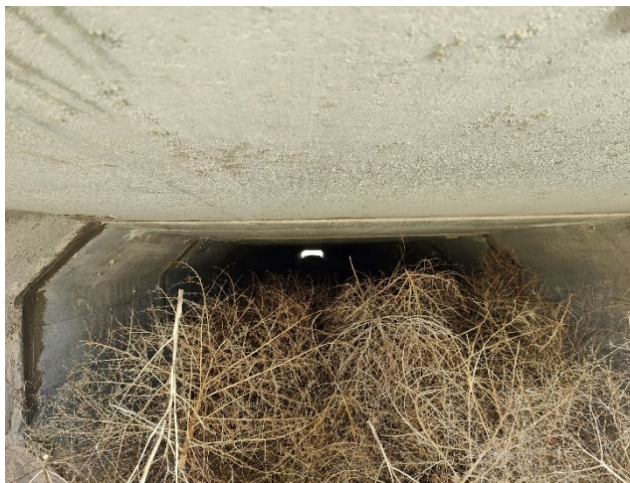
No culverts were found to have sediment greater than 4", and two culverts were found to have tumbleweeds impacting the water flow. Trash was not present in any inspected pipes. See **Figure 2-3** for an example of major tumbleweed blockage observed in a box culvert, and **Figure 2-4** for a picture of heavy scour observed at the front of the inlet apron for another culvert location. **Overall, the box culverts are in excellent condition with an average score of 99.80. The reinforced concrete pipes were also in the excellent condition range with an average of 99.73. Both drainage assets combined averaged a 99.77**

**Figure 2-3 – Box Culvert with significant tumbleweed build-up at MP 37.5**

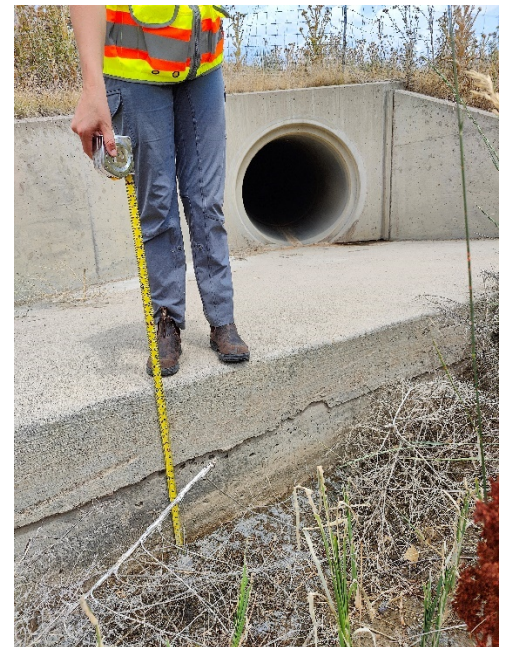
**Figure 2-4 – Box 2ft of scour at inlet of culvert near TPE (SB)**

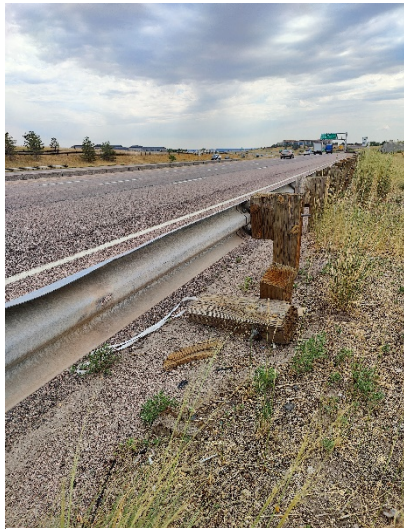
**Figure 2-5 – Minor guardrail damage near NB MP1**

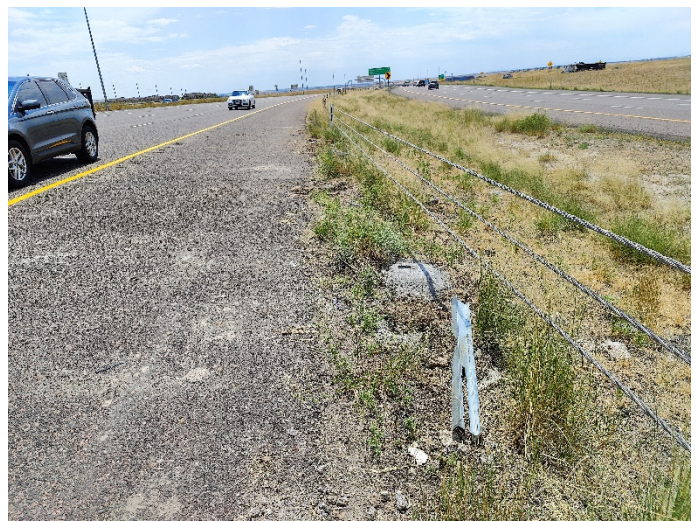
**Figure 2-6 – Stretch of damaged cable rail in median near 96<sup>th</sup> Avenue**

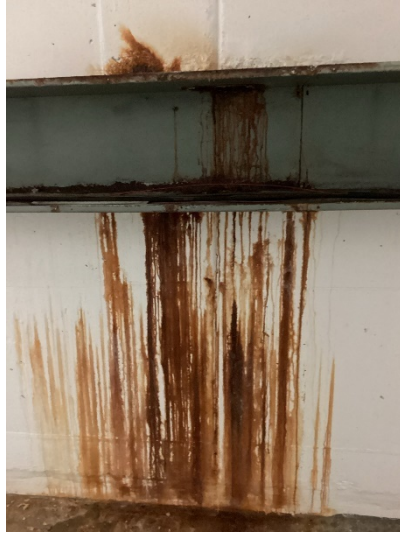
- **TP A:** The building is in excellent condition with an **overall rating of 89.67**. No Level One findings. Level Two findings were widespread water damage observed in both the main building and in the tunnel system. Areas with observed damage were ceiling panels, walls, around piping, etc. Drilled holes in the drywall were deemed Level Three findings. **Figure 2-7** displays the typical water damage and discoloration observed.

**Figure 2-7 – TPA – Water damage**

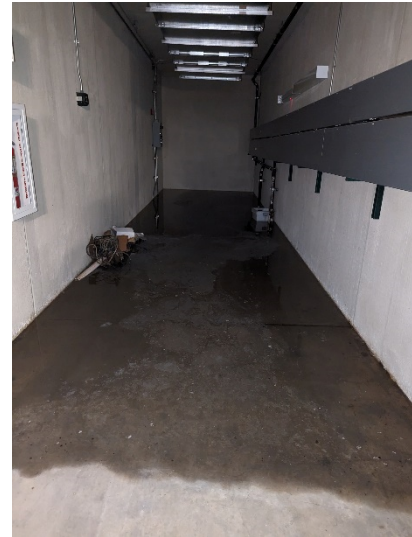
- **TP D:** The building is in excellent condition with an **overall rating of 92.67**. No Level One findings were noted. Level Two findings were water damage along the ceiling and walls and standing water in the tunnel area. Eleven ceiling panels were found to have water damage. Level Three findings consisted of a couple of cracks greater than 1/16" and small leaks in window gaskets. **Figure 2-8** showcases the standing water observed.

**Figure 2-8 – TPD – Standing water in tunnel area.**

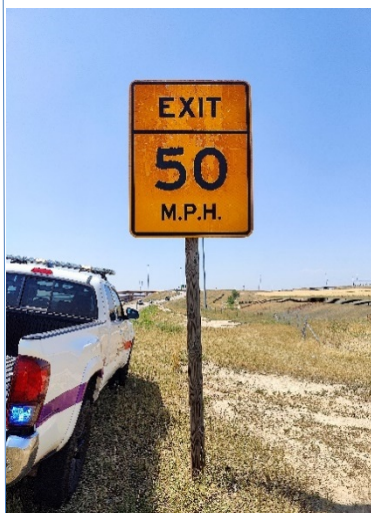
The most significant deficiency of the selected signs was that the 50mph exit caution sign at the northbound (NB) I-25 ramp was found to have poor reflectivity and damaged peeling paint.

Figure 2-9 – Faded peeling sign near I-25 North Ramp Exit

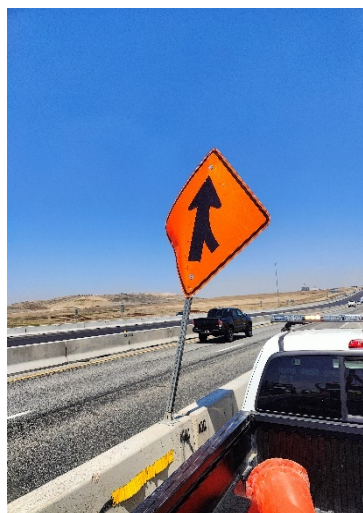
**Figure 2-10** shows an example of a sign which has been struck and bent by a passing vehicle while mounted on the jersey barrier. **Figure 2-11** highlights an example of the new signs which are currently resting on temporary stanchion, which will be relocated to its final proposed location once construction nears completion.

Figure 2-10 – Bent sign panel on out-of-plumb pole in work zone

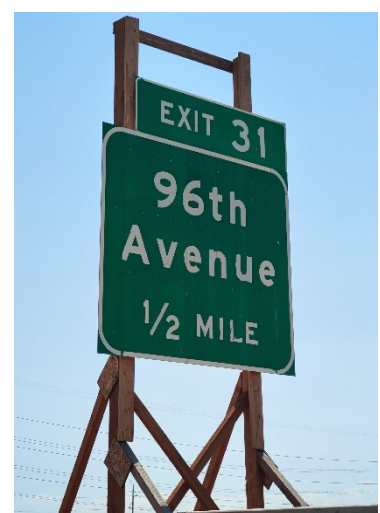
Figure 2-11 – New 96<sup>th</sup> Ave sign on temporary support structure

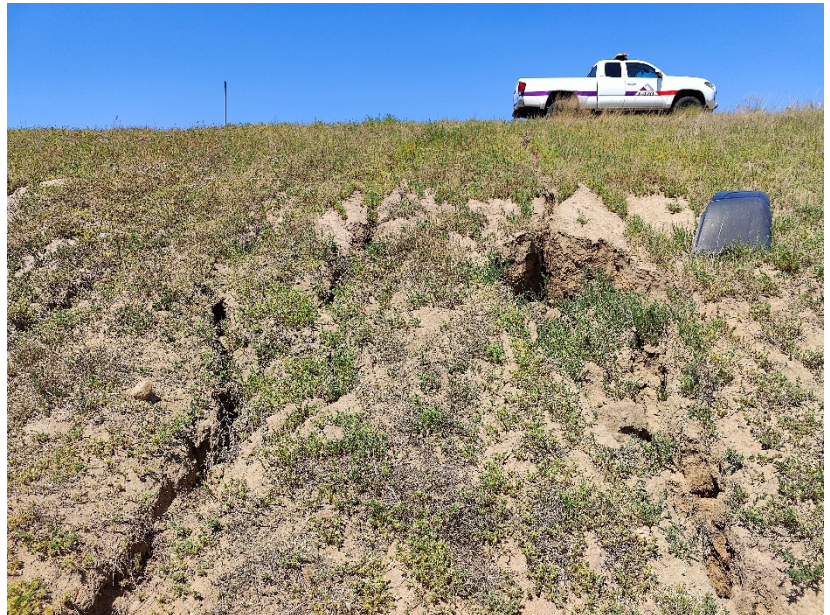
Heavy rain events in the previous year, mixed with windy dry months leading up to the July weeks of inspection, may have contributed to the erosion ruts and gaps in seeding observed. **Figure 2-12** displays an example of the deep rutting observed in three separate locations.

**Figure 2-12 – Multiple 12in+ ruts observed on embankment SE of I-76**

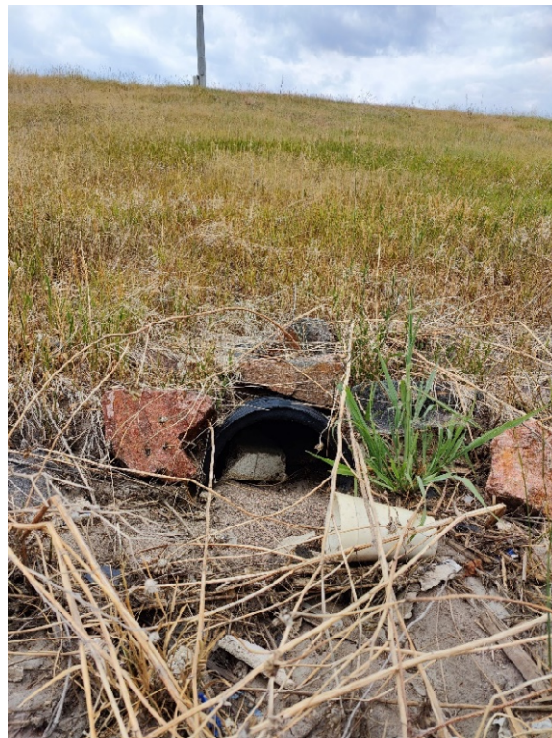
One location of note was the EP at the SW corner of S Parker Rd Bridge heading NB; the outlet of this EP was substantially clogged with a mixture of trash and sediment buildup. **Figure 2-13** below showcases this observed condition. **The overall condition of this asset is excellent, with an average score of 91.60.**

**Figure 2-13 – Trash and sediment buildup at EP outlet, SW of S Parker Rd Bridge (NB)**
